### State of Utah DEPARTMENT OF NATURAL RESOURCES Division of Oil. Gas & Mining

## **Inspection Report** Minerals Regulatory Program Date: April 27, 2010

Mine Name: Gardner Canyon/Nebo Gypsum Permit Number: S/023/0015		5
Inspection Date: 04/27/2010		
Time: 9:45 - 10:45 PM		
Mine Status: INA		
Evaluated	Comment	Enforcement
$\boxtimes$	$\boxtimes$	
$\boxtimes$	$\boxtimes$	
	Inspection Da Time: ← → Mine Status:  Evaluated	Inspection Date: 04/27/2010 Time: 9:45 - 10:45 Mine Status: INA  Evaluated Comment

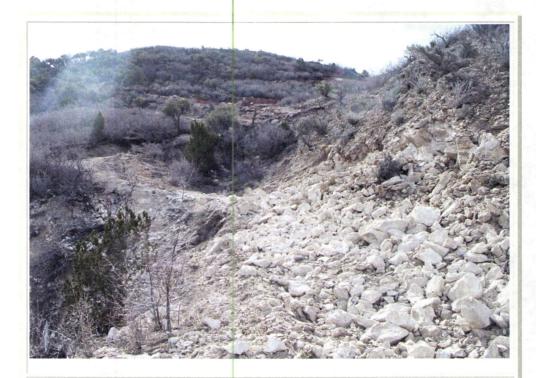
- 2. The road to the site is locked at the entrance of Gardner Canyon. The USFS restricts access to the site. Motor vehicle access to the site is restricted.
- Rocks blocked the road to the mine site. Near the blockage there was used shock cord, an exploded blasting cap and delays. The blockage appears to have been the result of blasting. The road to the mine site was in good condition but access to the site should be done with a four-wheel drive vehicle. The other roads at site were in good condition. There were no signs of erosion on any of the roads.

Road blocked near mine site.
